Survey on Water Cooling System's Failure Analysis for Diesel Electric Locomotives

R. K. Tyagi and Sukanya Borah***

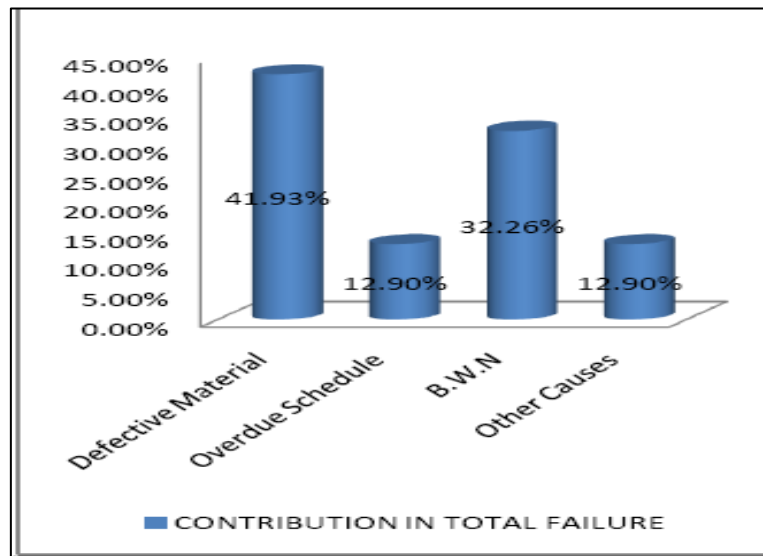
Line Failure

Cause	Contribution In Total Failure
Defective material	41.935 %
Overdue schedule	12.903 %
B.W.N/ mismanagement by crew	32.258 %
Other causes	12.90 %

41.9 % of line failure is due to defective materials which should be an important matter of concern for the railway authorities. It is very necessary to check the materials of the components on the very time it was supplied and only then it should be put to used in the locomotives. The main reasons for defective material are –

It is seen that almost 12.9% of line is due to overdue schedule i.e. the components which were

32.2% of the failures are due to B.W.N. This may be because of the negligence & lack of knowledge of the technicians.

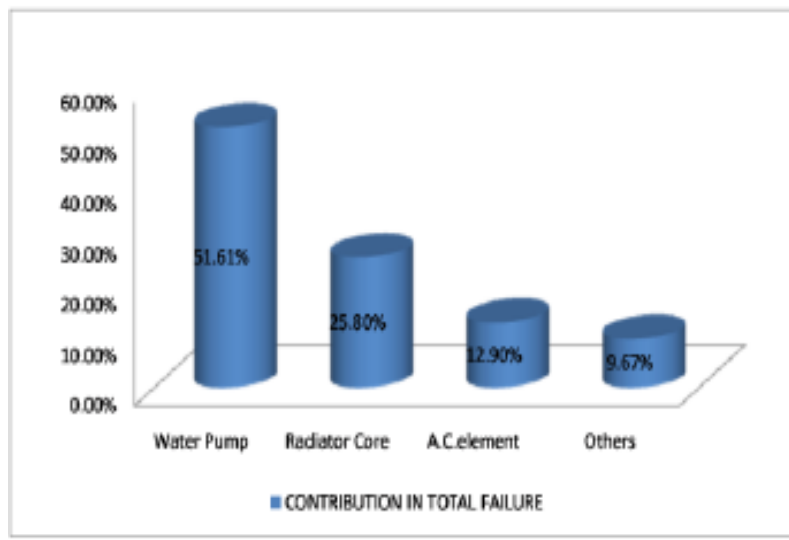
Shed Failure

Components Of W.C.S	Contribution In Total Failure
Water Pump	51.61%
Radiator Core	25.8%
A.C. element	12.9%
Others	9.677%

It is quite clear from the above table that almost half of the W.C.S failures are of the water pump failure. It is also found that the radiator cores suffer many failures. So, proper maintenance of the radiator core is required. I have done a very brief analysis on the failure records but even then i could find so many flaws in the maintenance of the W.C.sytem.
